DAMAGE THRESHOLD STUDIES OF GLASS LASER MATERIALS

FINAL TECHNICAL REPORT

30 June 1972

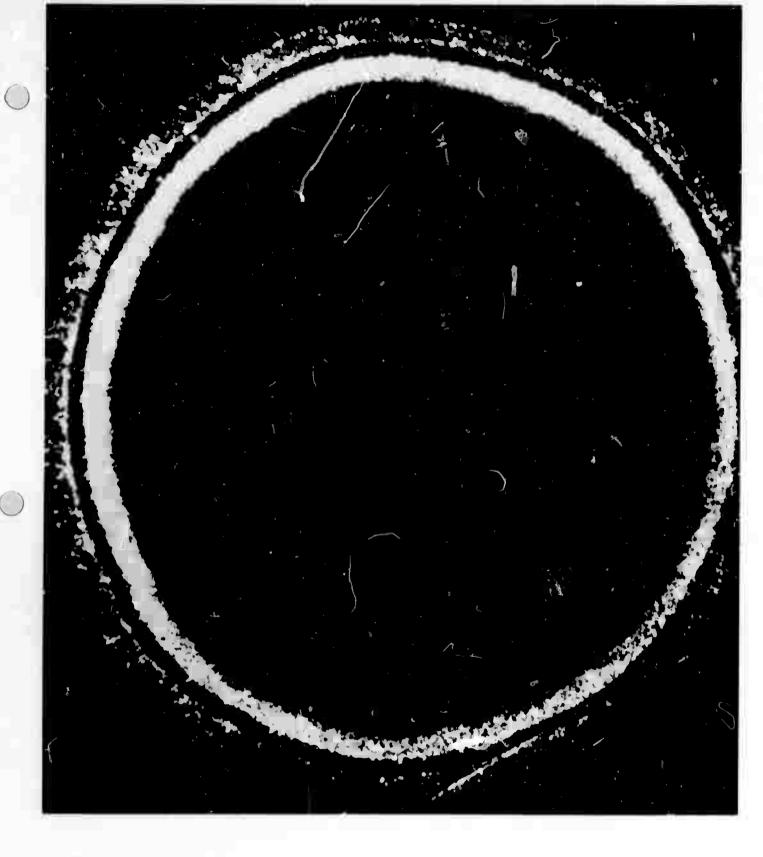
Figure 6 shows damage that is typical of either the entrance or exit surface for energy densities near threshold. The ring structure seen in the photo consists of material deposited on the surface. This deposit cannot be removed by hard rubbing with acetone or isopropyl alcohol. The form of the structure varies; sometimes it consists of a single ring and sometimes it consists of several concentric rings. The diameter of these rings can range from approximately the diameter of the damaging beam to several times this size. In Figure 6 the ring structure is 4mm across while the beam was 1.8mm. Generally, the diameter of the ring increases with the energy of the beam. Although the effect is not easily discernible in micrographs, the surface inside the rings always exhibits a rippling or "orange peel" appearance.

Figure 6 - The ring structure shown in this figure is typical of damage for either the entrance or exit surface when the incident pulse is near threshold.

Occasionally, some cracking of the surface is seen inside the ring at this stage. Since the rings can be much larger than the damaging beam, it can be concluded that they are caused by the plasma and not the beam. This conclusion is supported by the absence of rings on a glass in which damage occurs without an accompanying plasma.

A possible explanation of ring formation is as follows. The initial plasma is formed in the region of the damaging beam. Its temperature is greater than 104 °K as it begins to expand over the surface. 21 The hot plasma heats the surface where it comes into contact with it. It is this heating that causes the ripple effect seen at both surfaces at this stage of damage. The plasma is cooled by expansion and by contact with the cooler surface. As the plasma cools, different components condense out at different temperatures, forming the system of rings. This explanation is consistent with the observation that cracking or rippling of the surface never extends beyond the ring but sometimes fills the entire ring. Confinement of damage to the interior of the ring indicates that the plasma is significantly hotter inside the ring than outside. Furthermore, on the basis of this explanation it might be expected that the most volatile component of the glass would be evaporated by the plasma first and the ring structure, when there is a single ring, would consist primarily of this component. In the case of ED-2 the most volatile component is Ligo. The composition of a single ring was analyzed with an Auger spectrometer and it was found that the ring was rich in lithium compared to the surrounding unchanged glass. This observation is consistent with the results reported in Reference 13. A multiple ring structure has not yet been analyzed.

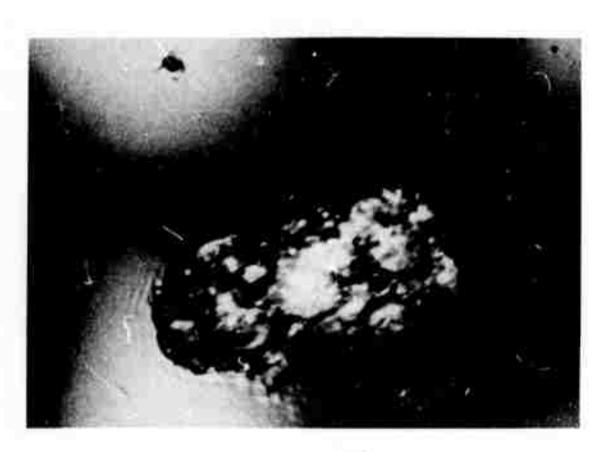
Figures 7 and 8, respectively, show typical entrance and exit damage at energy densities well above the damage threshold. Energy densities in excess of 1.4 times the threshold are sufficient to cause pitting of the exit surface. Pitting becomes more severe as the energy density is increased. The cracking seen at the entrance surface never extends beyond the ring structure associated with the shot causing the damage, but the network of cracks sometimes grows and continues to fill in the ring several hours after the damage is perpetrated. This behavior is seen often on surfaces which have been mechanically strengthened by inducing a high compressional stress in the surface through an ion exchange process.

Figure 8 - Exit damage when the incident energy density is well above threshold.

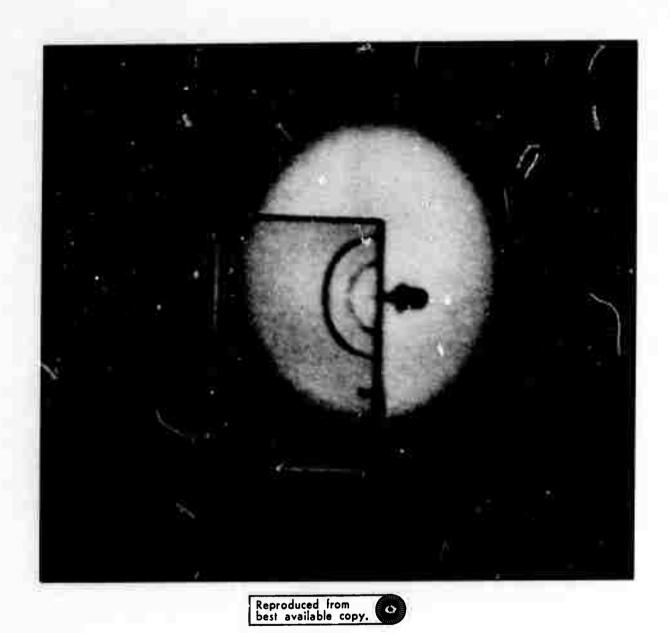
Holograms taken as early as 45 ns after the peak of the damaging pulse show that material from the crater is expelled during the damaging pulse. This material is initially expelled at speeds of about 5×10^6 cm/sec, and continues to be expelled more than a microsecond after the damaging pulse. It is mostly emitted normal to the surface. This is apparent in Figure 11 which is a single exposure hologram taken 900 ns after damage initiation.

Figure 11 - Damaged cube 900 ns after passage of the damaging pulse.
